Elevated Temperature Fracture of RS/PM Aluminum Alloy 8009

William C. Porr, Jr., Yang Leng, and Richard P. Gangloff
Department of Materials Science and Engineering

Funded by NASA Langley Research Center

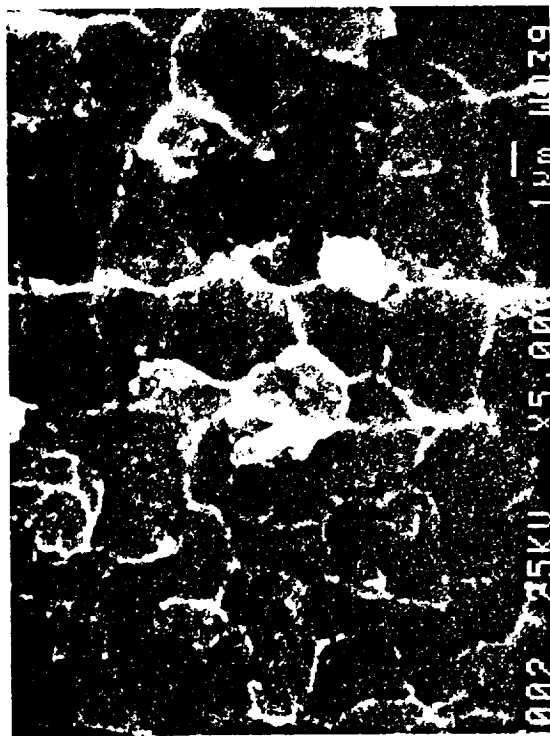
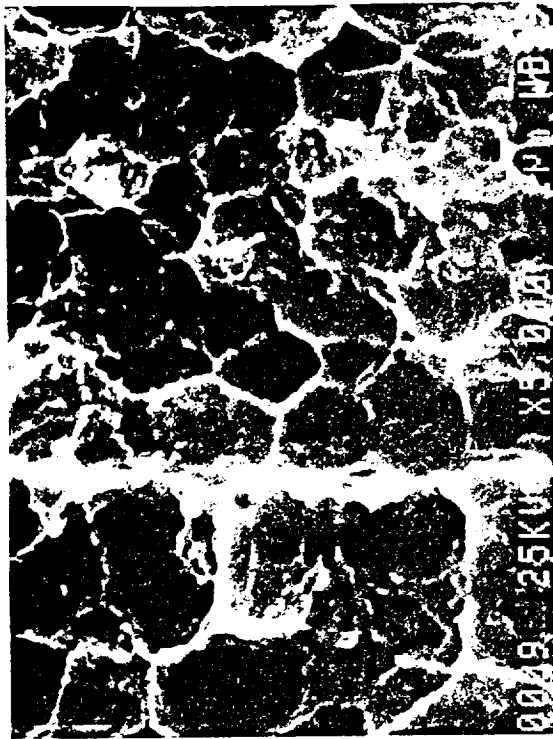
High magnification SEM photographs of matching fracture surface features.
Specimens tested in air at 175° C.

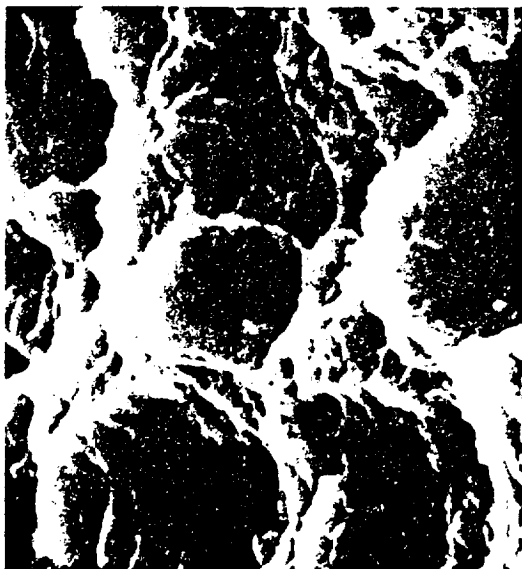
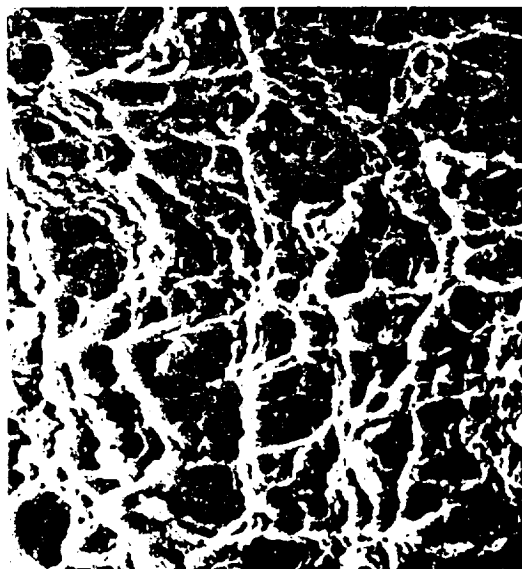
25° C, Air

- ■ 25°C: dual distribution of dimples –
.5 to 2 μm and 4 to 8 μm
